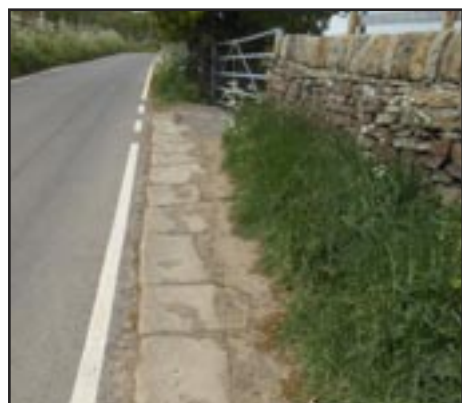
Two examples of causey paving in the Lakeland area: running alongside Thornhouse Lane, Bright-holmlee on the left and the footpath across Swan Heights on the right.

2. Causeways. Some tracks were protected by a "causeway" or "causey" - fortifying a boggy part of the route by stone paving. Ideally this was constructed from very strong rectangular flagstones but sometimes what was nearby was used -ie rough and ready boulders placed with the smooth side uppermost. These sorts of trackways are narrow with 27" being the average. This could result in a considerable groove being worn by the use of shod ponies over the years. Steps can also be seen in these paved ways which are surprisingly easy for animals to manage. This sort of paving was always put in for horses, pack and ridden, and never just for walkers - although walkers will have used them too. Causeways would often have been created before the walls existed and this is why many of the fragments that remain run alongside walls. The wall would have been built next to the old track for convenience

maybe even incorporating some of the causey stones.

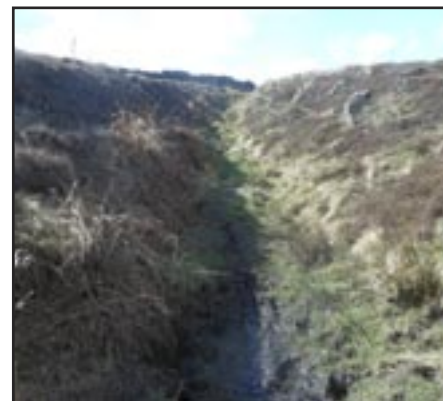
Two examples of hollow ways: Rocher Lane, nr Bolsterstone and Hob Lane footpath to Spout House Hill.

Some of these routes have evolved over a thousand years. Well used paths became hollow ways due to erosion. A hollow way is a narrow track or road with steep banks on either side.

The deeper they are probably the older or more important they were. If there were no restrictions (such as walls) then you can see lots of little "furrows" where a multitude of routes developed, where the track moved to avoid the eroded sections. Not all hollowed out bits of the terrain are connected to packhorses, but if it is already on a route (footpath or lane) the chances are that it is.

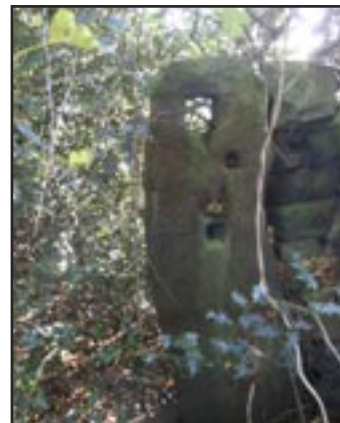
Old stone gatepost on Storth Lane bridleway, Wharncliffe Side.

3. Old gate posts. In passing from one parish to another or through isolated settlements there would be gateways flanked by great millstone grit posts with slots or holes cut in or through the stone to hold wooden posts and hinges. The gate posts that have metal fixings or hinges are from the time of the Enclosure Awards in the late 18th and early 19th centuries when many new walls were also built. There are plenty of ancient stone gateposts with holes in the Lakeland area which are a good indication of much older roads and tracks.

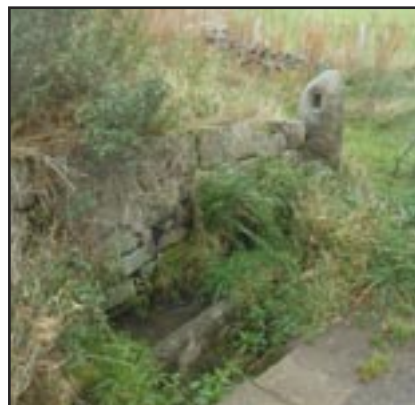
Water trough and gate post, Reynard Lane, Stannington.

4. Old stone water troughs. Water availability is always needed with working horses, ridden, pack or cart. Numerous water troughs, fed by springs and streams, have survived in the Sheffield Lakeland Area on footpaths, bridleways and roads. Some are now virtually buried in undergrowth.

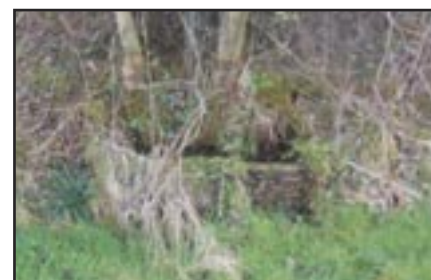
Hidden water trough on a footpath called Bents Lane, Stannington

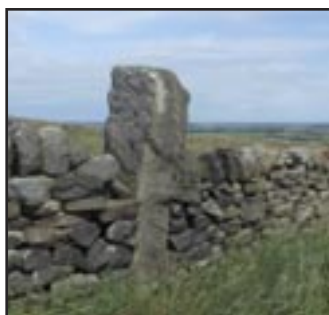
A single stone incorporated into the wall. Bolsterstone Road, Swanheight

5. Waymarkers and guide stoops. The practice of waymarking is ancient, although standing stones probably originated for ritual purposes they became acknowledged waymarkers for the pack horse routes. Other stones, cairns and posts were erected along the line of the track on the brow of a hill so that they could be seen and followed from either direction. Many of these ancient stones and posts were crosses and were often installed by the local Abbey as guides for pack horse trains. Remember that these routes were crossing vast tracks of land without walls.

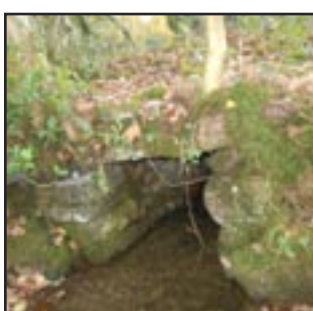
However there are many other humble culverts (see photo on left) on old routes still waiting to be discovered.

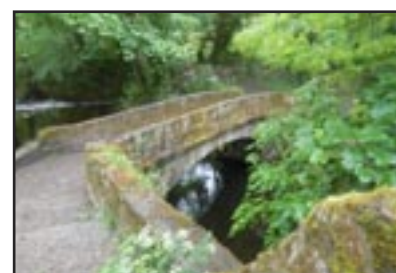
Rivelin pack horse bridge.

6. Pack horse bridges and culverts. Only four pack horse bridges remain in the Sheffield Lakeland area of which the one over the River Rivelin, built c1775, is a very fine example. Pack horse bridges are always narrow (6 foot wide, or less) with very low or no parapets so that the loads did not catch on the sides. Stone bridges tended to replace old wooden ones. Culverts are far more common in this area, and some that have been built for lanes can be high and well engineered.
